Gerbera: *Diagnosing Interveinal Chlorosis of Upper Leaves*

*Upper leaf interveinal chlorosis (yellowing) of gerbera (*Gerbera jamesonii*) is an indicator of iron (Fe) deficiency and may be a result of waterlogged substrates, high substrate pH, or underdeveloped root system.*

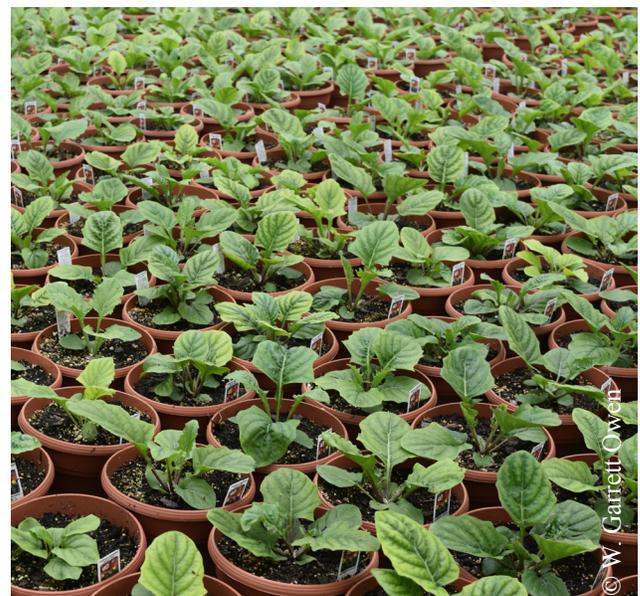
While visiting a grower, we came across a gerbera crop (Fig. 1) that exhibited interveinal yellowing (chlorosis) of the upper leaves (Fig. 2). Though the degree of interveinal chlorosis varied among individual plants (Fig. 3), the typical symptoms pointed towards high substrate pH and thus, iron (Fe) deficiency. However, without following the diagnostic process, we would have been fooled.

Figure 1. Gerbera (*Gerbera jamesonii*) crop exhibiting interveinal chlorosis of the upper leaves.

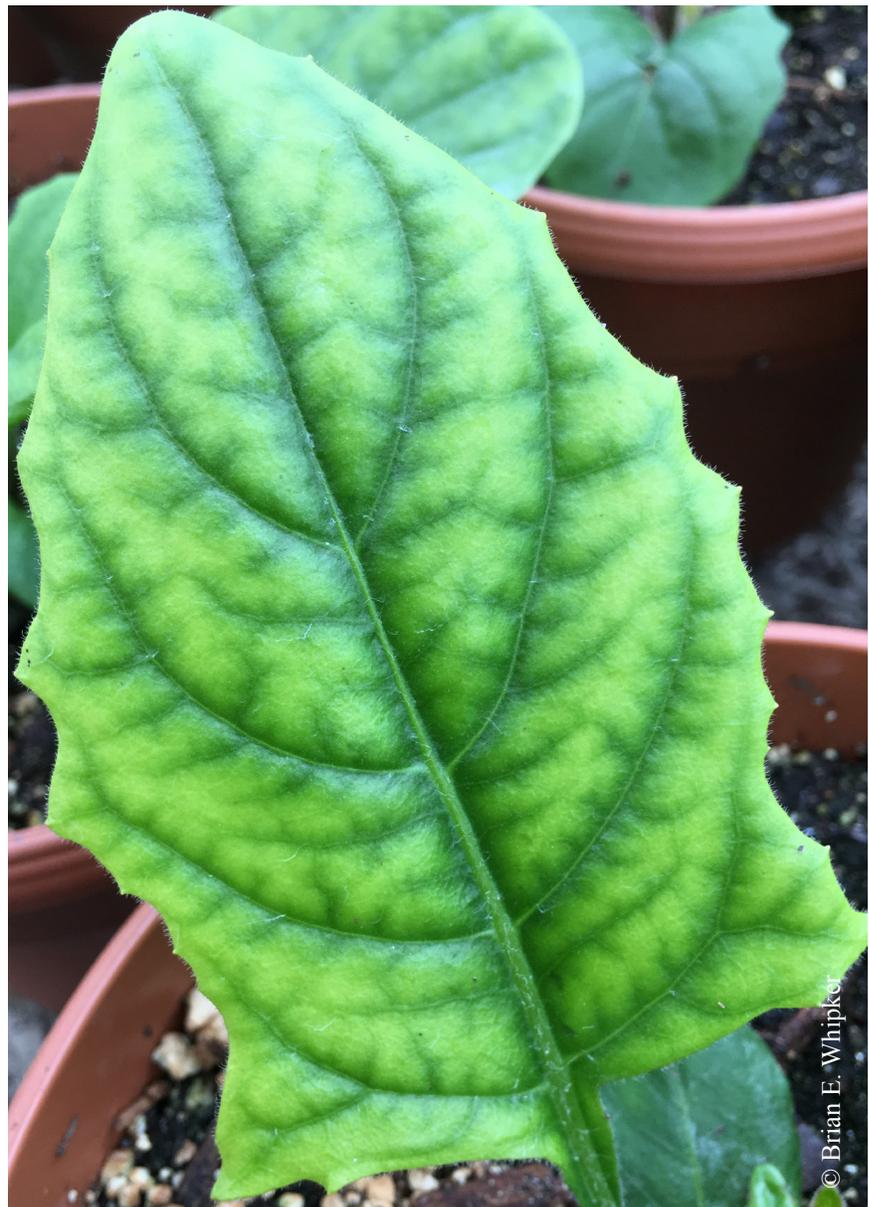
Figure 2. Interveinal chlorosis of the upper leaves of an individual gerbera (*Gerbera jamesonii*) plant.

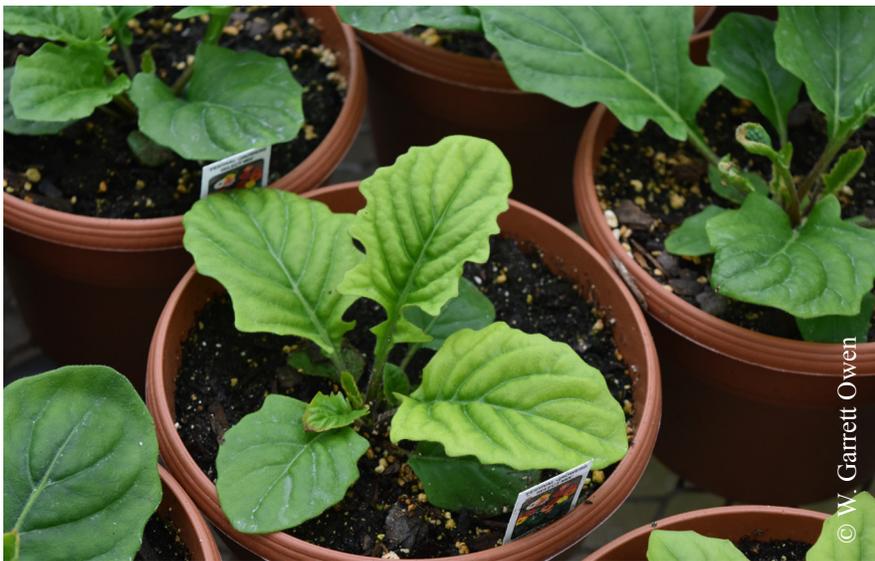
Figure 3. Varying intensity of interveinal chlorosis among gerbera (*Gerbera jamesonii*) plants.

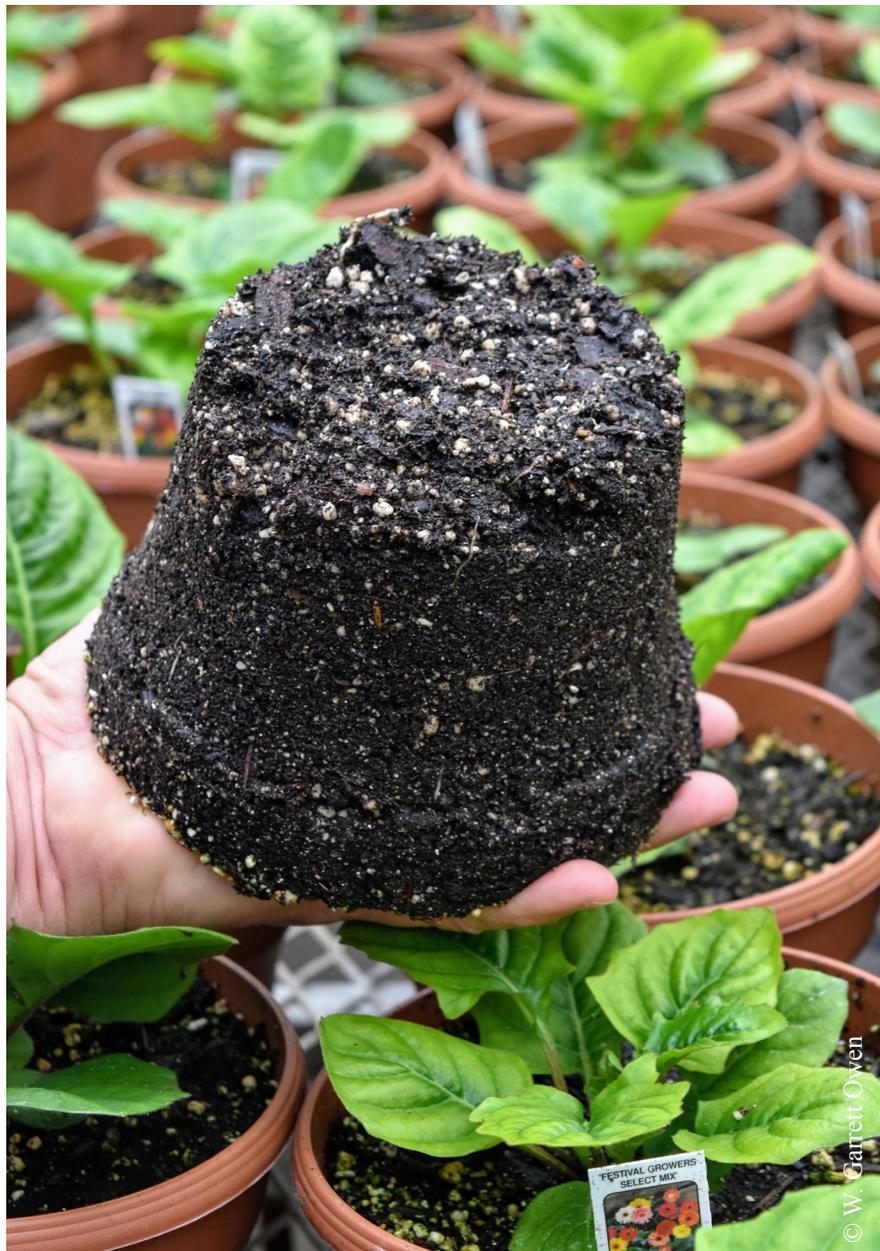
The results of the PourThru indicated pH and electrical conductivity (EC) values of 5.8 and 4.41 mS/cm, respectively. The pH was within the recommended range (pH 5.8-6.2), though the EC was 2 to 4 times higher than the recommended EC of 1.2-2.4 mS/cm. In addition, we inspected the root system of multiple plants. We found that the gerbera plants lacked a well developed root system (Fig. 4).

We concluded that the interveinal chlorosis was a result of small root systems because of high EC as a result of excessively wet or waterlogged substrates. Essentially, leaching or irrigating until drip out of the bottom of the pot was not occurring at each weekly irrigation event. The grower feared that if plants were irrigated until leaching, the pots would never dry out under the current outdoor environmental conditions. Without leaching, the soluble salts accumulated in the rhizosphere, stunting or inhibiting root growth. Furthermore, because of the waterlogged substrate, the gerbera plants were unable to absorb Fe.

Figure 4. Gerbera (*Gerbera jamesonii*) plants lacked a development root system.

Leach the substrate of soluble salts by irrigating the crop with acidified water until the leachate begins to drip from the bottom of the container.

The substrate should be irrigated with 10 to 20% leaching to avoid accumulation of soluble salts (EC). Decrease the fertilization rate so leaching is not required.
